**Ref.:** Filtri Carburante Eco  
Eco Fuel Filters

## DETERIORAMENTO FILTRI CARBURANTE ECOLOGICI

## ECOLOGICAL FUEL FILTERS DETERIORATION

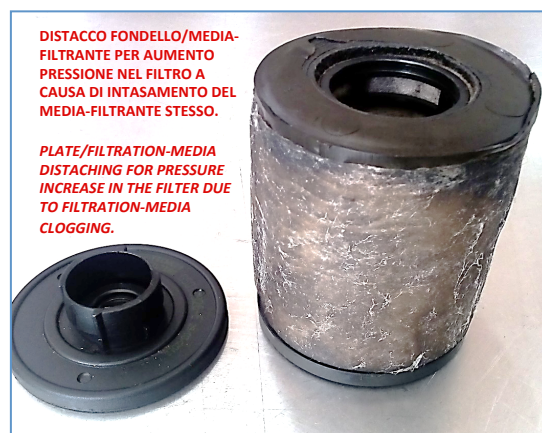
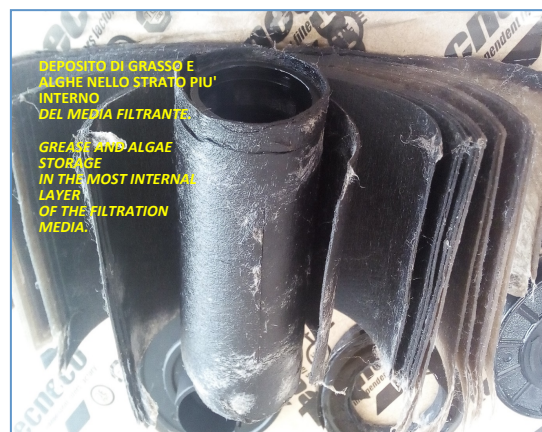
Per la pubblicazione di questo report tecnico siamo partiti da un caso reale accaduto ad un ns. Cliente. Nello specifico parliamo di un filtro carburante **CS010026-E** con applicazione su motori FIAT Multijet, anche se una situazione del genere può verificarsi su qualsiasi auto e con qualsiasi filtro carburante eco/immersione. Come visibile dalle foto a lato, il filtro in questione risulta essere notevolmente deteriorato, la parte più esterna del media filtrante si presenta particolarmente scura rispetto a quanto dovrebbe essere in un filtro che ha lavorato in condizioni normali. Sezionando il filtro, poi, si nota come la parte più interna del media filtrante, sia completamente nera a causa di un fortissimo intasamento da alghe, grasso e sedimenti vari che ostruiscono il normale flusso di carburante. E' chiaro che il rallentamento del flusso di carburante a causa dell'ostruzione dei pori del media filtrante ha inevitabilmente provocato un aumento improvviso di pressione e temperatura del carburante che ha cristallizzato le parti in plastica del filtro provocandone anche il distacco.

In fin dei conti questo filtro ha fatto il suo dovere e non poteva fare altro, mentre bisognerebbe capire quali siano le ragioni per le quali il filtro si sia potuto intasare così tanto, che proviamo ad ipotizzare come segue.

- **Qualità del carburante utilizzato** ; con tempi di stoccaggio lunghi e alte % di Biodisel, causa della formazione di alghe e morche, assorbite dal filtro.
- **Tempi sostituzione filtro troppo lunghi (oltre 30.000 km)** ; molto al di sopra dei tempi raccomandati per la sostituzione del filtro stesso.

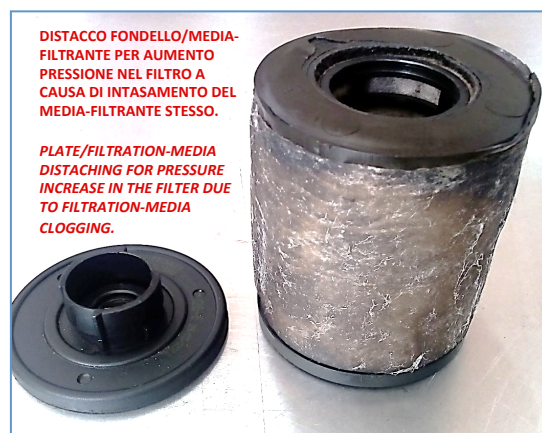
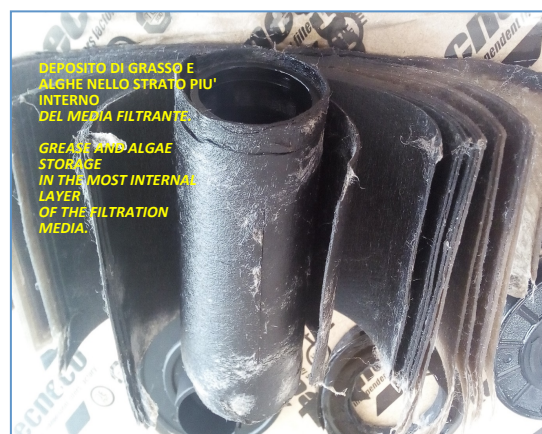
For the publication of this technical report we started with a real case, happened to a Customer. Specifically we talk about a fuel filter GS010026-E with application on FIAT engines Multijet, even if such a situation can occur on any car and with any fuel filter. As shown in the photos on the side, the filter in question turns out to be noticeably deteriorated, the outermost part of the filtration media it is particularly dark compared to what it should be in a filter that worked under normal conditions.

media  
filtration media is completely black due to a very strong clogging from algae, grease and various sediments that block the normal fuel flow. It is clear that the slowdown of fuel flow, due the pore obstruction of the filter media, inevitably has caused a sudden increase in pressure and temperature of the fuel, that has crystallized the plastic parts of the filter provoking also the detachment.

After all, this filter did its duty and could not do something else, while we should understand what the reasons are for which the filter has been able to clog so much, that we try to hypothesize as follows.

- Quality of the fuel used ; with storage times long and high % of Biodisel, due to the formation of algae and dead, absorbed by the filter.
- Filter replacement times too long (over 30,000 km) ; much above the recommended time to replace the filter itself.
