16/15 Report Tecnico / Technical Report (27/07/15)

Ref.: Filtro carburante GS8029/1 in sostituzione di GS8029
Fuel filter GS8029/1 as replacement of GS8029

Nuovo filtro carburante GS8029/1

New fuel filter GS8029/1

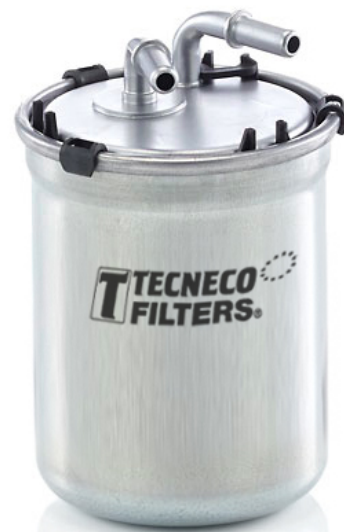
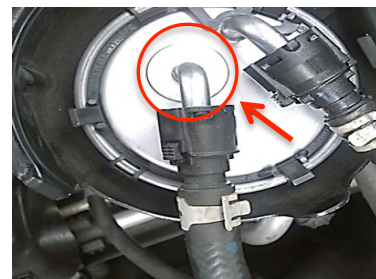
Nello specifico la modifica apportata consta nell'applicazione di una rondella metallica, di rinforzo, applicata per mezzo di brasatura, in corrispondenza del tubetto "IN" di mandata del carburante nel filtro.

Questa modifica strutturale del filtro (apportata anche sul filtro originale di primo impianto) si è resa necessaria perchè le forti oscillazioni e vibrazione, che i motori di applicazione hanno per loro natura, provocavano la rottura del tubetto di entrata del carburante proprio in prossimità del suo innesto nella testata del filtro.

Specifically, the modification consists in applying a metal washer reinforcement, by brazing, in correspondence of the "IN" tube for the fuel inlet in the filter.

This filter's structural change (performed even on genuine filter) has been necessary because strong oscillations and vibrations, by engines in application, caused the breaking of the fuel inlet tube "IN", precisely near its graft in the filter head.

A partire dal mese di Luglio 2015, il nuovo filtro carburante GS8029/1 sostituisce il precedente GS8029 oggetto di richiamo per problemi strutturali, a far data dal 18/02/15 - Rif.0057/15.

Since July 2015, the new fuel filter GS8029/1 replaces the previous GS8029 re-called for structural problems on 18/02/15 Ref.0057/15.
