Ref.: Filtro olio eco OL010066-E - OL0246-E - OL0247-E
Eco oil filter OL010066-E - OL0246-E - OL0247-E

Rottura crocetta di rinforzo interna al filtro per eccessiva spinta valvola contenitore

**Breaking of inside filter
cross-break reinforcement
for container valve
excessive pressure**

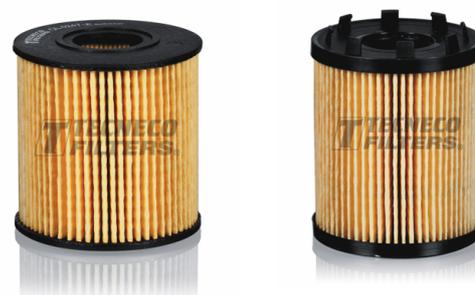
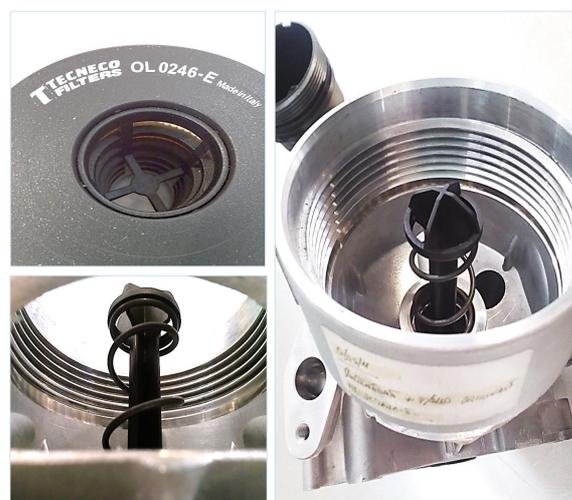
I filtri olio eco con codice **OL010066-E, OL0246-E, OL0247-E**, hanno al loro interno un rinforzo cilindrico in nylon PP6, con nel mezzo una crocetta per l'apertura della valvola di flusso olio. A volte, a causa di alcuni sedimenti dell'olio depositati tra le spire della molla presente all'interno della valvola di flusso, questa si stacca e non riesce a comprimersi sotto l'azione della pressione dell'olio. Si avrà così una notevolissima spinta della valvola contro la crocetta del filtro, che pur essendo già stata notevolmente rinforzata, potrebbe rompersi.

*The eco-oil filters with code **OL010066-E, OL0246-E, OL0247-E**, have a cylindrical nylon PP6 reinforcement inside, with a cross in the middle, for opening of the oil flow valve. Sometimes, due to some oil deposits in the spire of the spring, you will have an high pressure push against the valve which could break the cross, which has already been remarkably high reinforced.*

A tal proposito suggeriamo di verificare, almeno ad ogni sostituzione del filtro, l'assenza di detriti depositati tra le spire della molla installata sulla valvola di flusso, per evitare spiacevoli inconvenienti, come la rottura della crocetta.

We suggest to check, at least for each replacement of the filter, the absence of debris deposited between the turns of the spring inside the flow valve, to avoid unpleasant troubles, such as breaking the cross.
